Computed Tomography is Diagnostic in the Cervical Imaging of Helmeted Football Players With Shoulder Pads

Objective: Prospective, observational case series evaluating the value of cervical spine computed tomography (CT) scans in the initial evaluation of a helmeted football player with suspected cervical spine injury.

Design: Multiple 3.0-mm, helically acquired, axially displayed CT images of the cervical spine were obtained from the skull base inferiorly through T1, with images filmed at soft tissue and bone windows. Sagittal and coronal reformatted images were performed. Software was used to minimize metallic artifact.

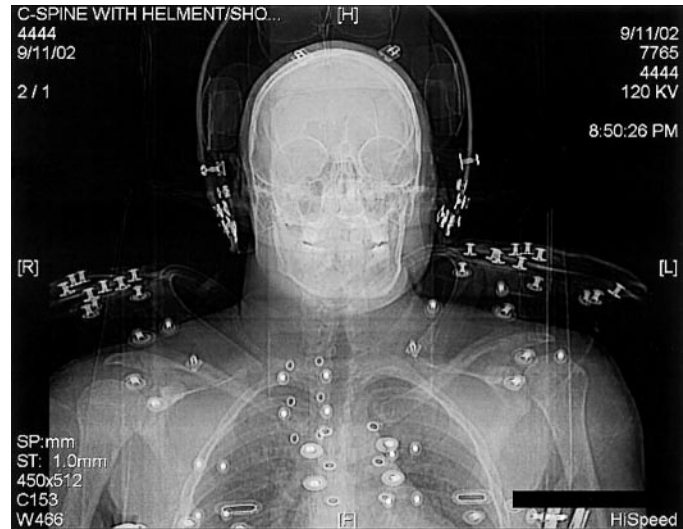
Figure 2. Anteroposterior scout view from standard computed tomography (CT) examination. Note numerous metallic snaps and clips. Few radiodense materials overlie the midline and cervical spinal column.

structive than the shoulders in affecting spine visualization. Anteroposterior scout films (Figure 2) and all bone window images (Figures 3 and 4) were of full diagnostic quality. The soft tissue windows (Figures 5 and 6) showed minimal localized artifact occurring at the same levels as seen in the lateral scout views. This minimal beam-hardening streak artifact did not affect the diagnostic quality of the soft tissue windows.

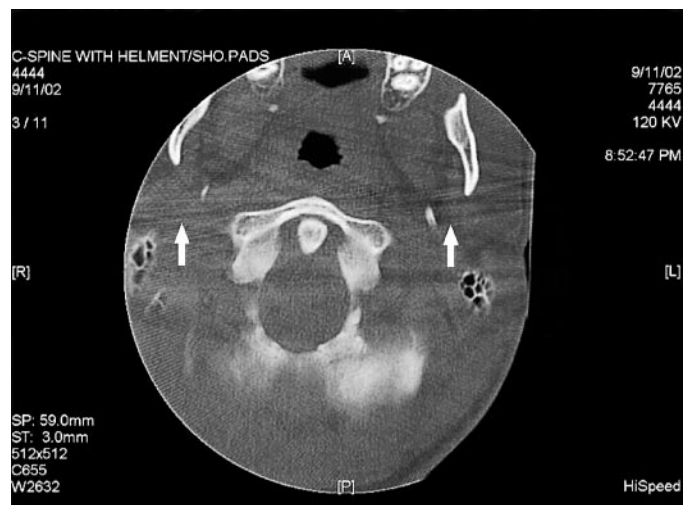
Figure 3. Axial computed tomography (CT) image, bone window, at C1–C2 level (same level as Figure 6). Streak artifact (arrows) from the external metallic clips does not interfere with evaluation of bone integrity.

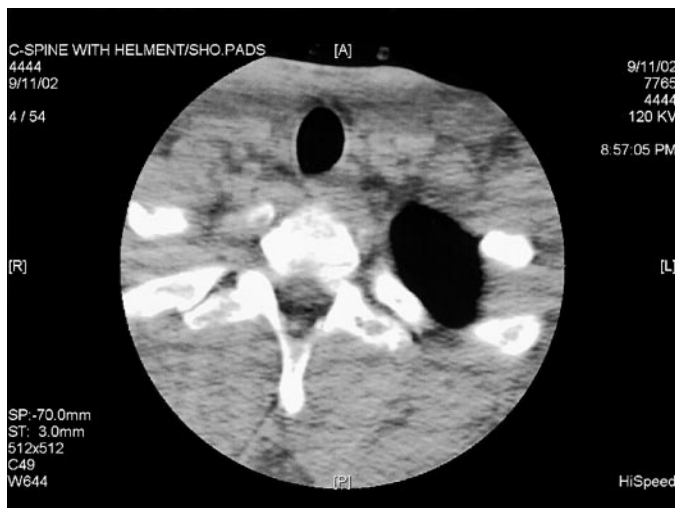
Figure 5. Axial computed tomography (CT) image, soft tissue window, at T1–T2 level. Mild image degradation (lack of sharpness) is due to the patient's large shoulders. Streak artifact is not present. Higher cervical levels are less affected. Films are fully diagnostic.

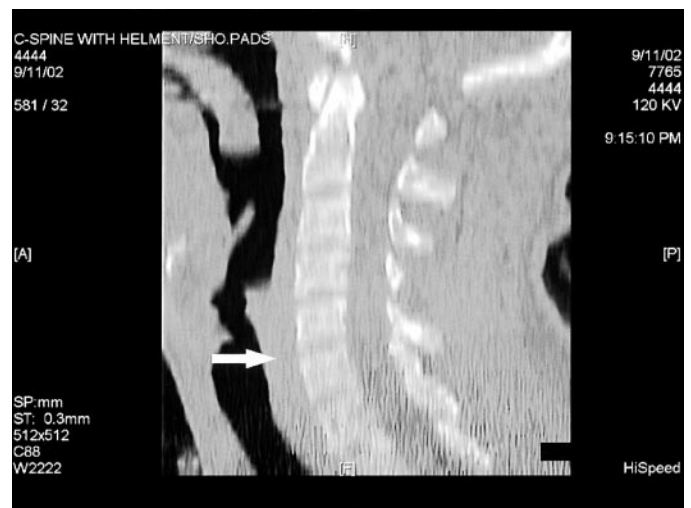
Figure 7. Two-dimensional midline reconstruction, bone window. Loss of detail from C6 inferiorly is due to the patient's large shoulders and not due to the presence of the shoulder pads. Axial computed tomography (CT) images are fully diagnostic in an area that has often been difficult to evaluate on conventional radiographs.

Reconstructed images (Figure 7) were uniformly of full diagnostic quality.
